96 Cyfyng Road, Pantteg Landslip
Ground Investigation Report

Prepared for:
Neath Port Talbot County Borough Council, Environment, The Quays, Baglan
Energy Park, Brunel Way, Briton Ferry, SA11 2GG

Document Reference: **ESP.5859e.07.2937**

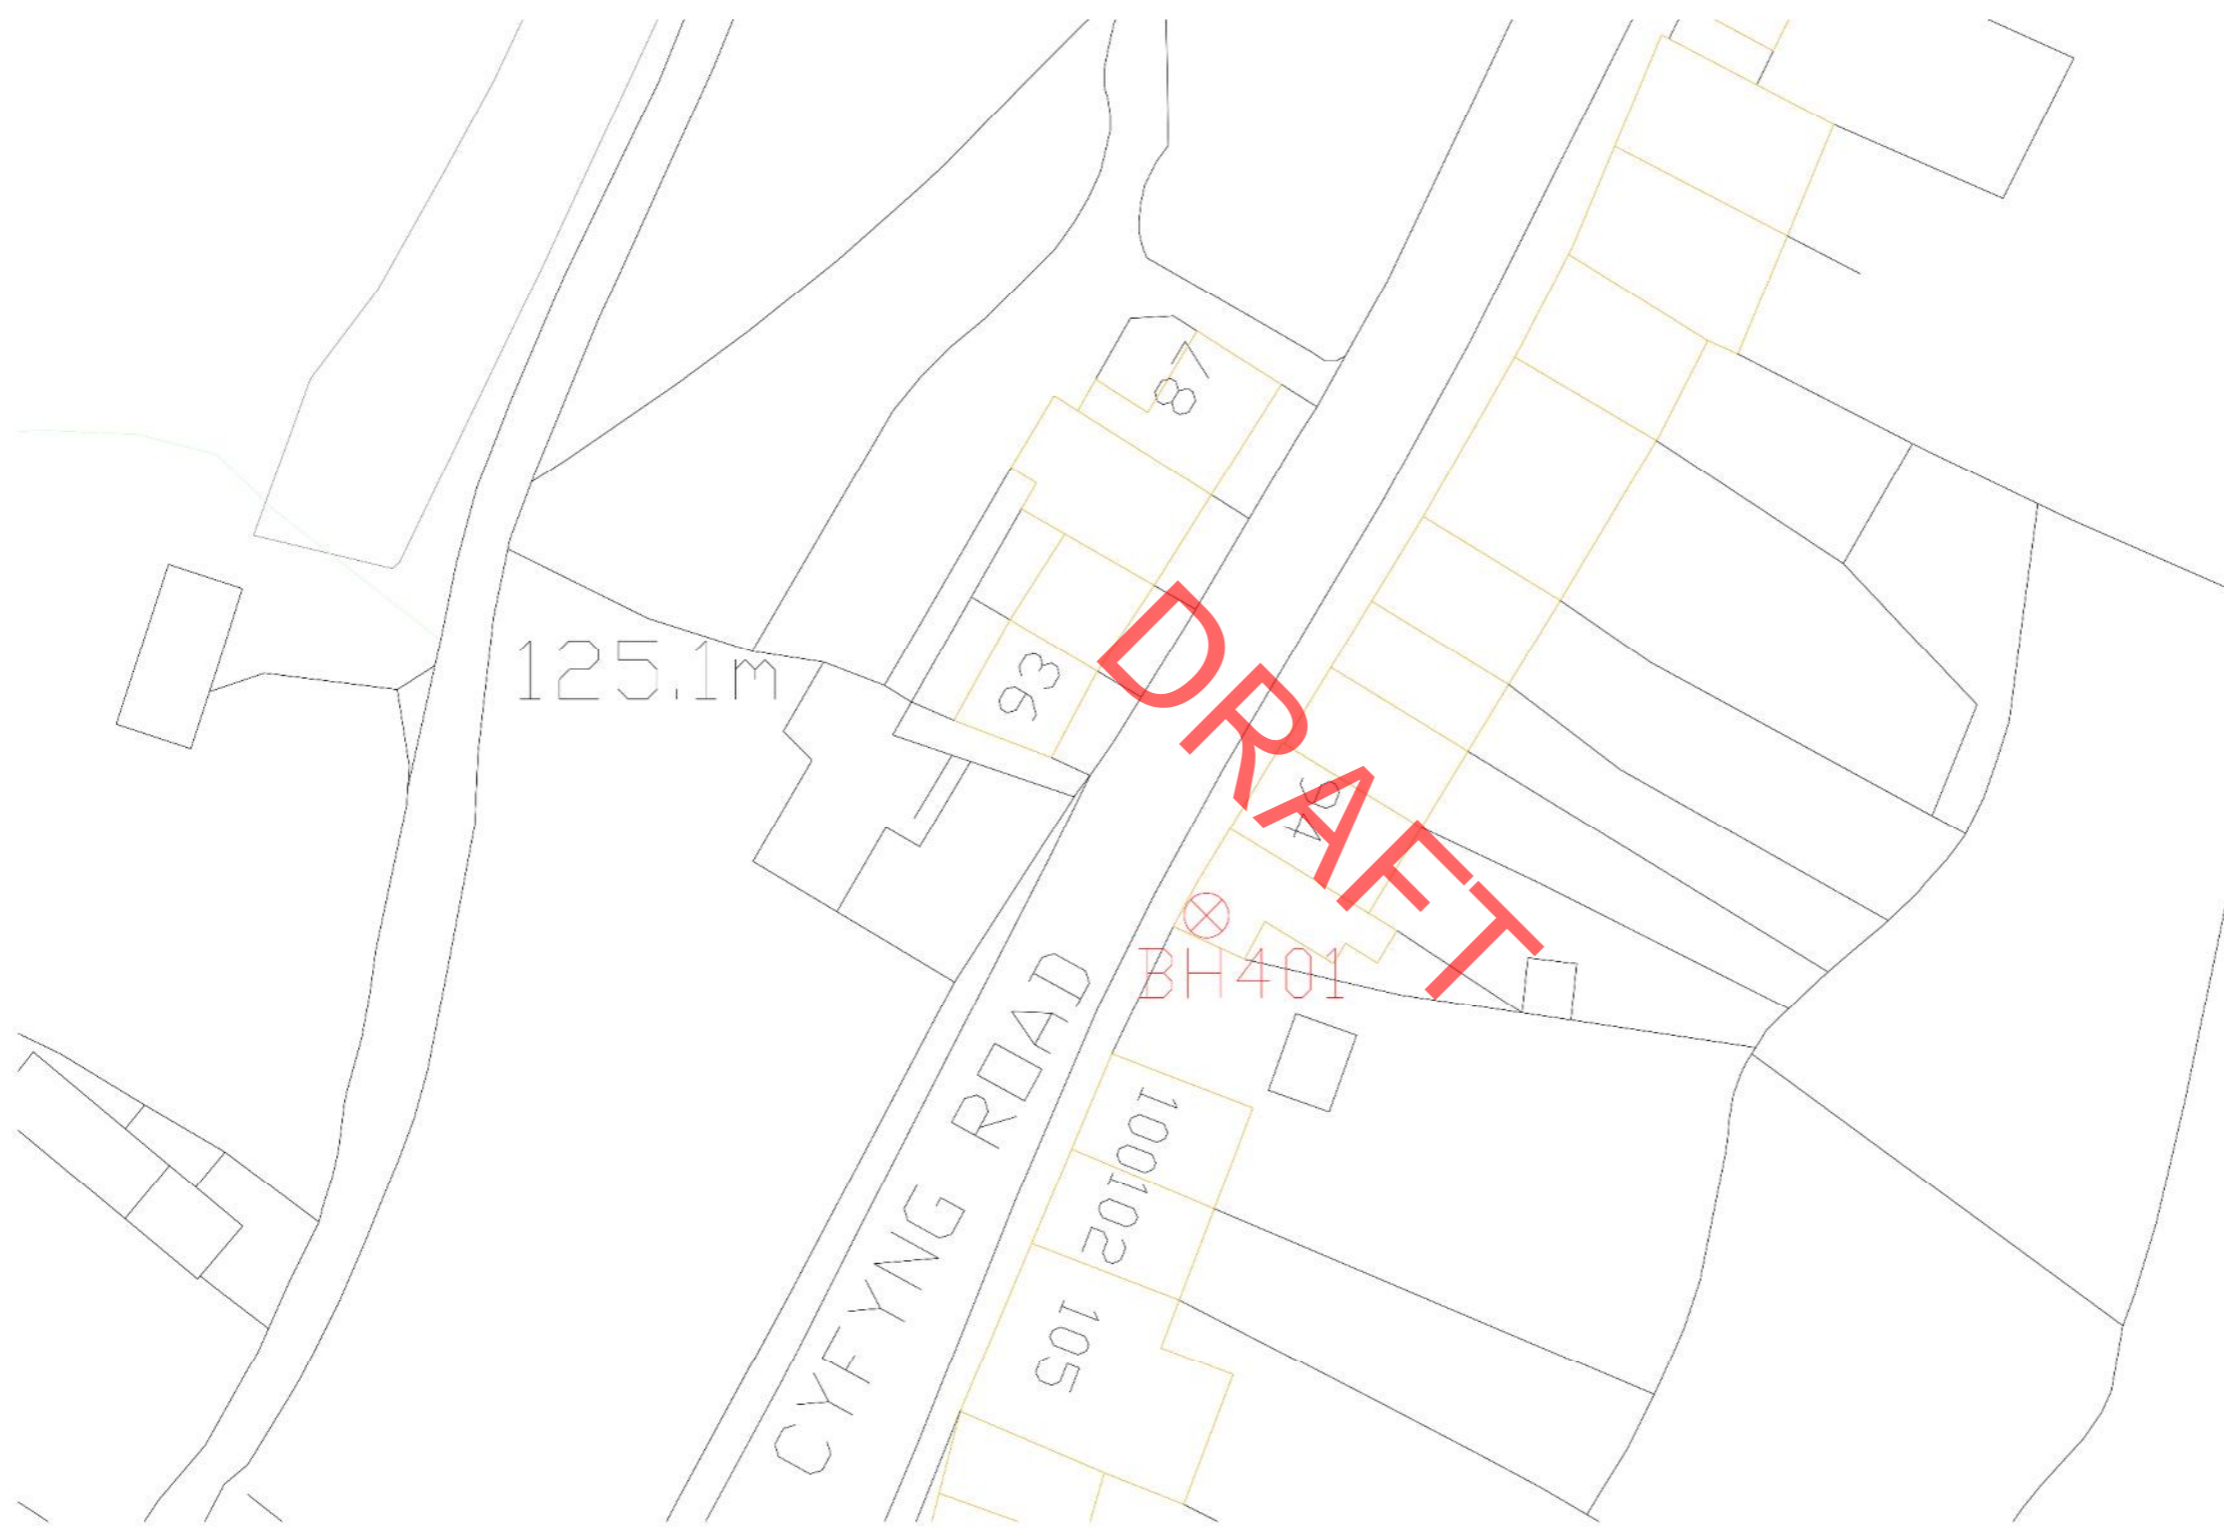
Figure 1

The site is the land directly south of the now derelict 96 Cyfyng Road. The grid reference for the borehole location is approximately 276270 208270. The borehole location plan is shown as Figure 1.

Borehole Location

FIGURE 1:
EXPLORATORY HOLE LOCATION
PLAN

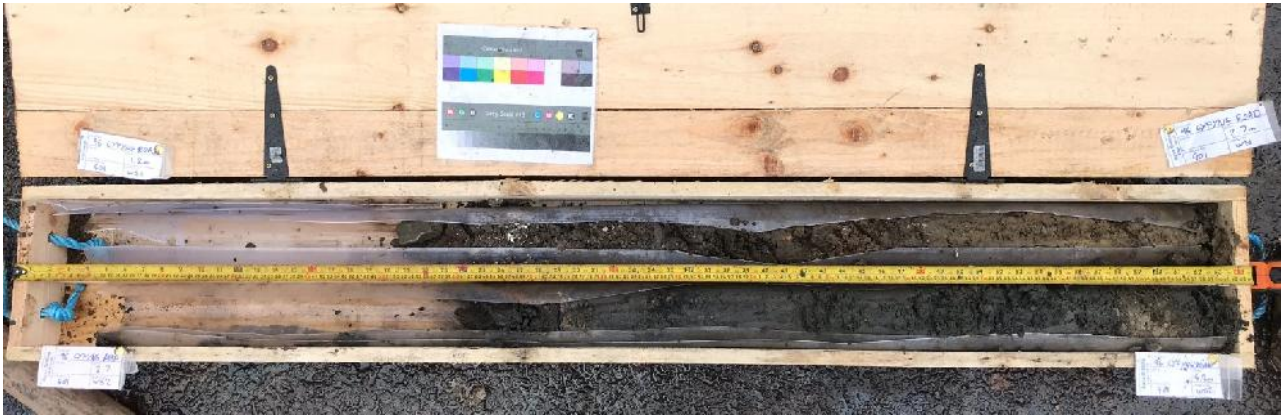
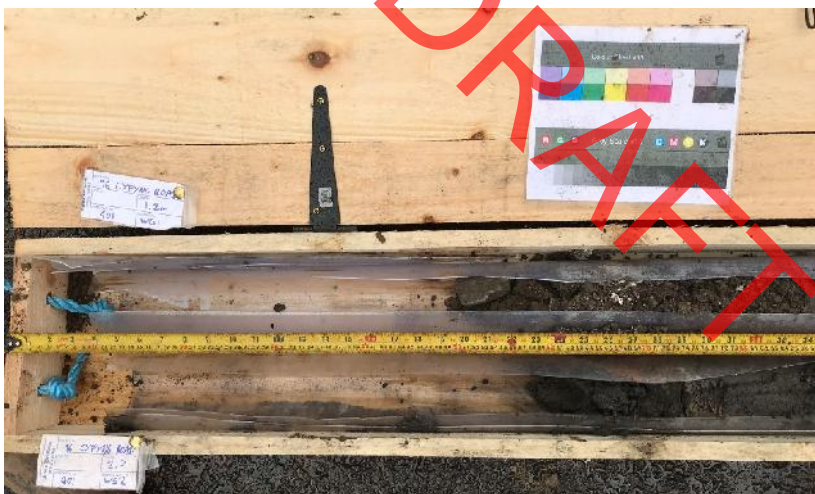
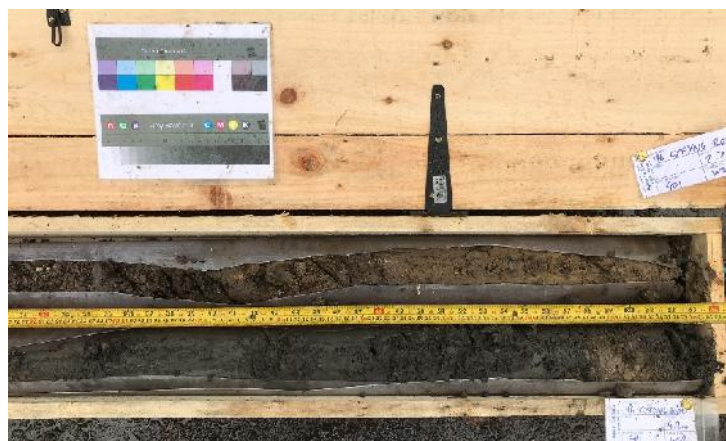
APPENDIX B – CORE PHOTOGRAPHS

Borehole: BH401

Depth range: 1.2 – 4.2m

Full core box overview

Encountered to a depth of 4.2m as either; sandy gravel and cobbles of sandstone, with some coal; brown mottled orange gravelly clay, with gravel of fine to coarse mudstone, siltstone and coal; grey silty sandy gravelly clay with wood and slag fragments.

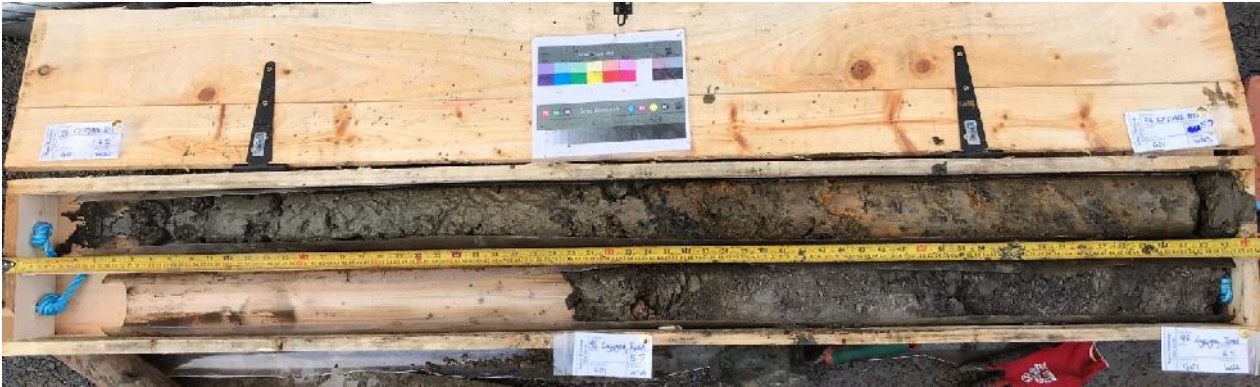
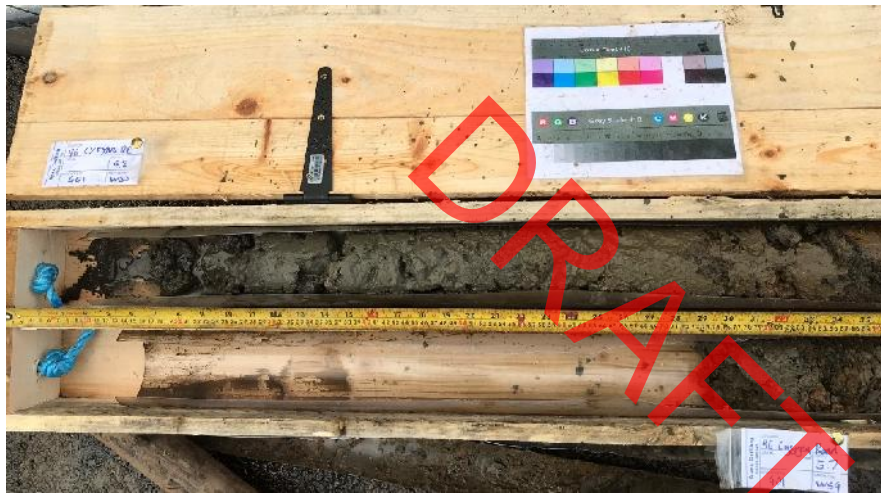
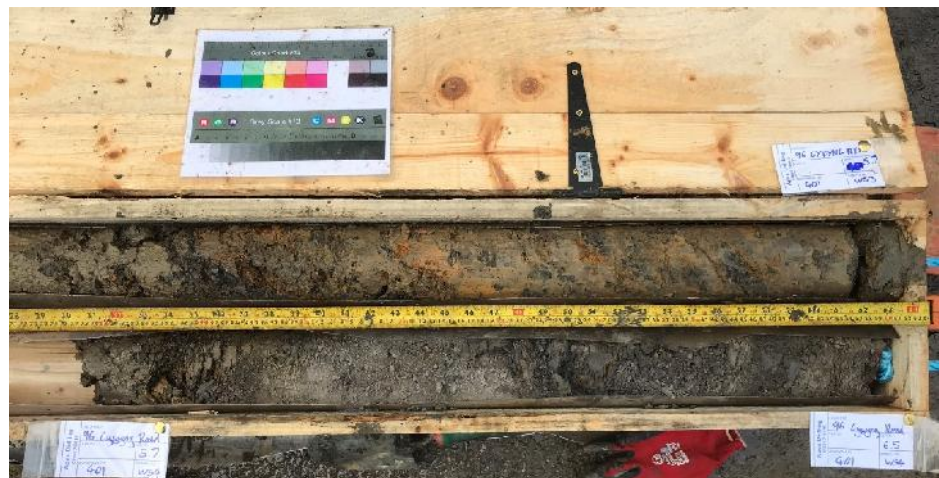
Borehole: BH401

Depth range: 4.2 - 6.5m

Full core box overview

Grade E material encountered is firm brown, orange-brown and grey gravelly sandy clay, with a gravel of fine to coarse, angular, tabular siltstone.

Grade D material is encountered as very dense occasionally clayey, sandy gravel of fine to coarse angular siltstone or mudstone. Orange-brown surface discolouration is present on the surface of the gravel.

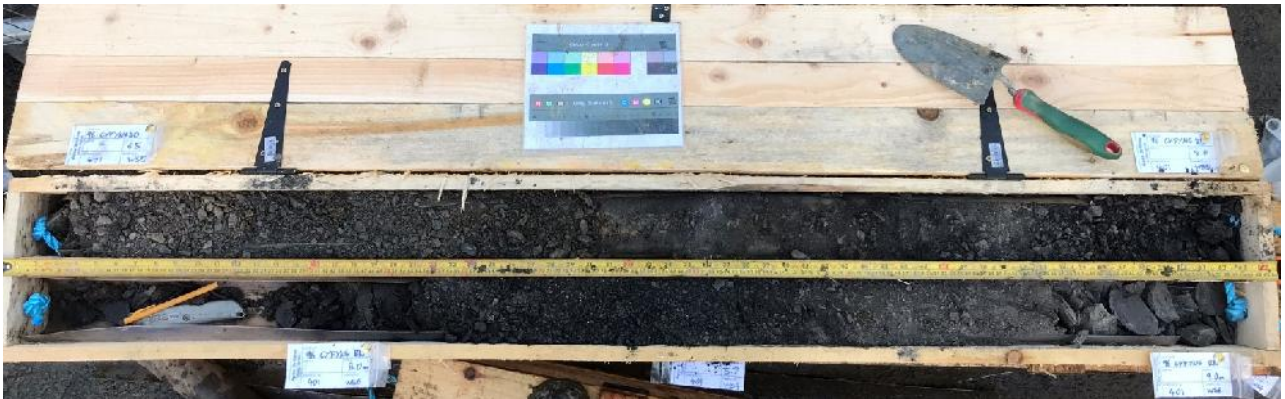
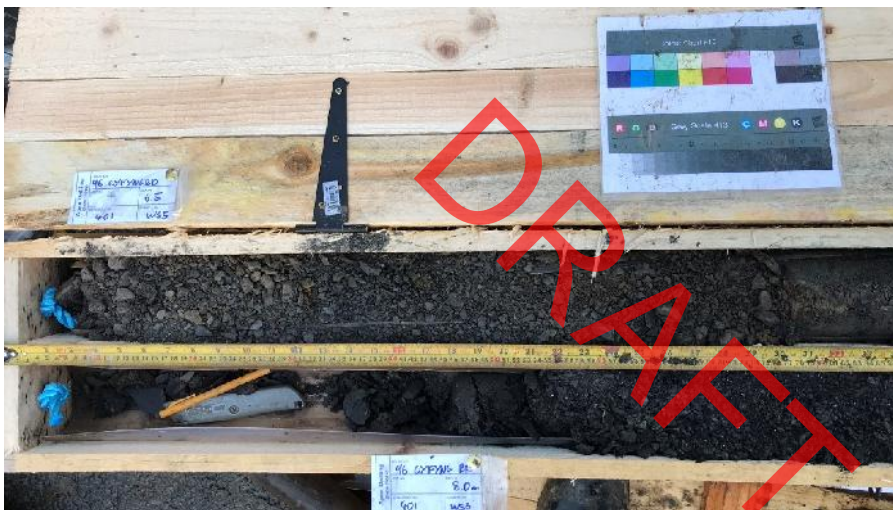
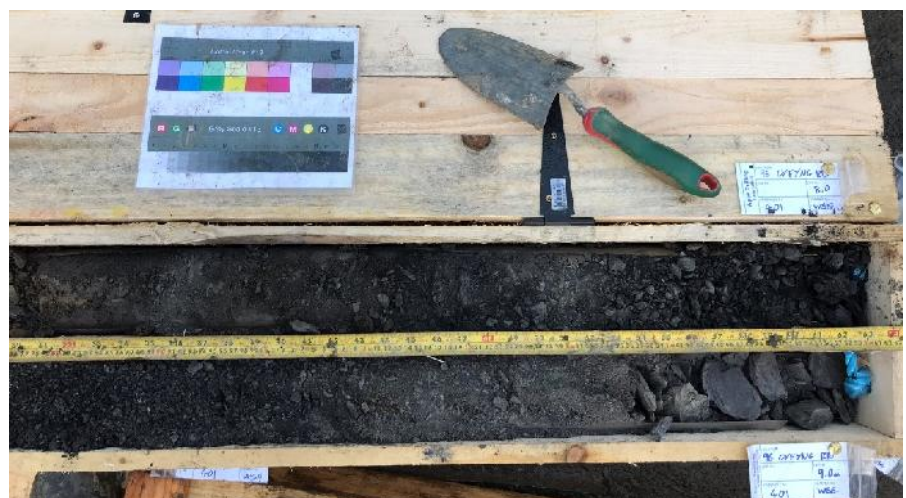
Borehole: BH401

Depth range: 6.5 – 9.0m

Full core box overview

Grade B material is encountered as very weak black partially weathered mudstone with orange discoloration on fracture surfaces.

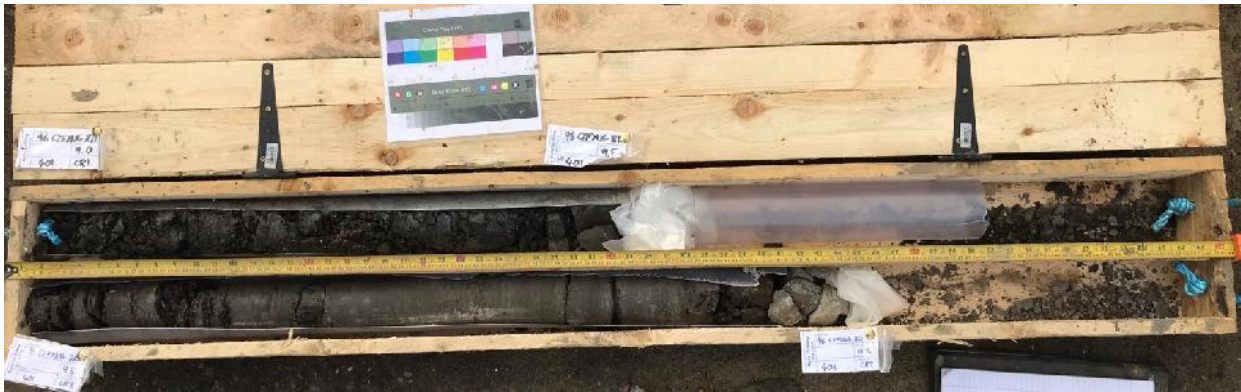
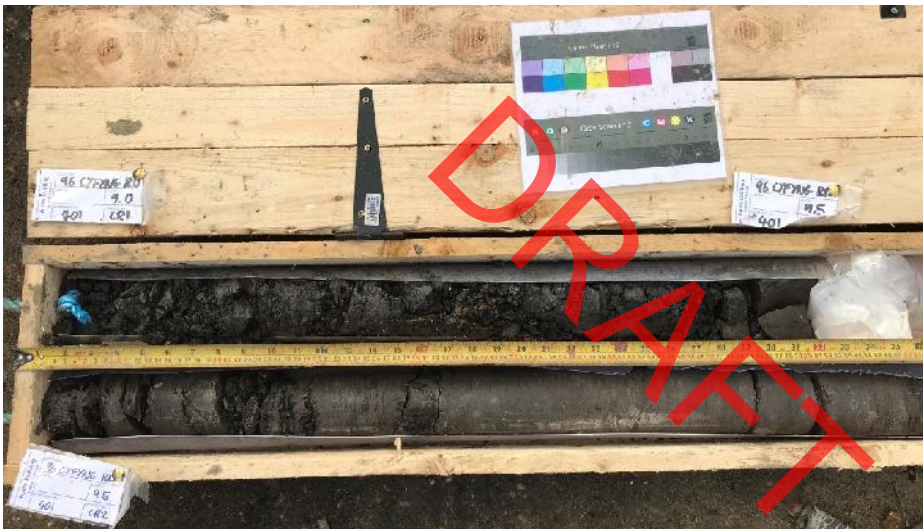
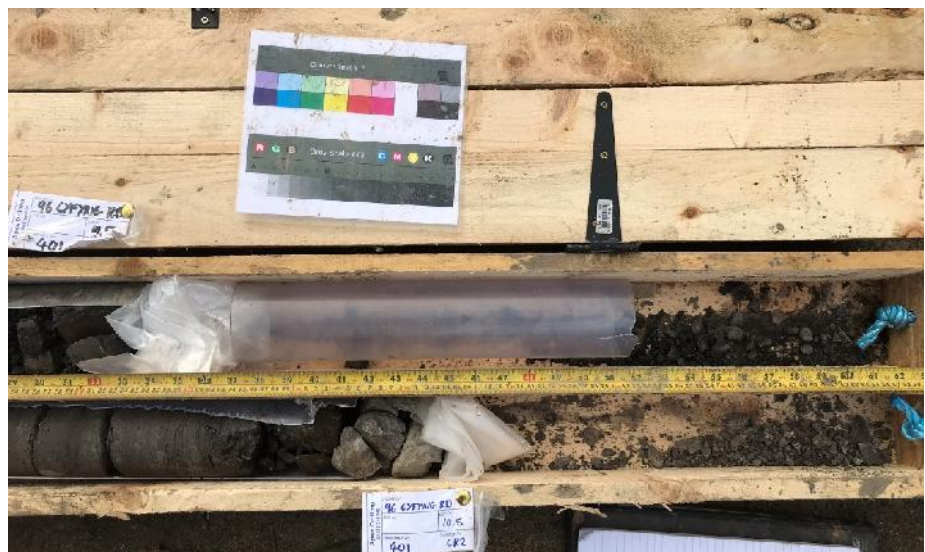
Borehole: **BH401**

Depth range: **9.0 - 10.5m**

Full core box overview

Unweathered bedrock is encountered from 9.45m to the base of the borehole, as a weak to very strong dark grey sandy siltstone, with a high content of fossilised plant material.

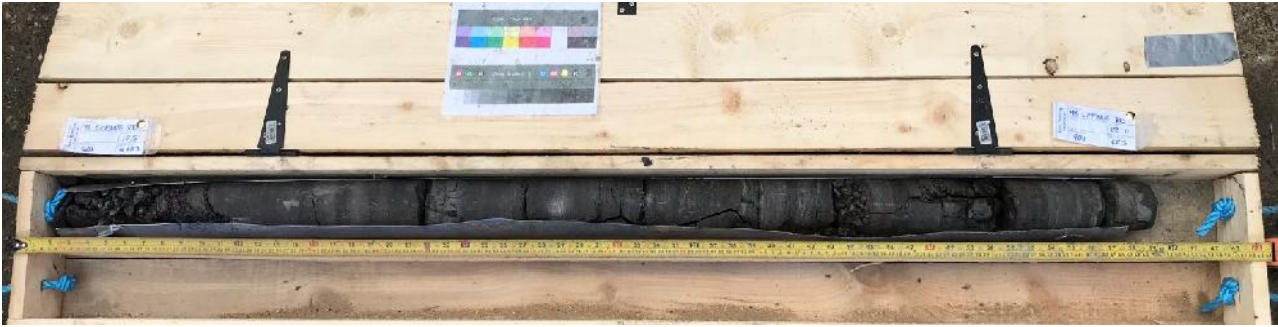
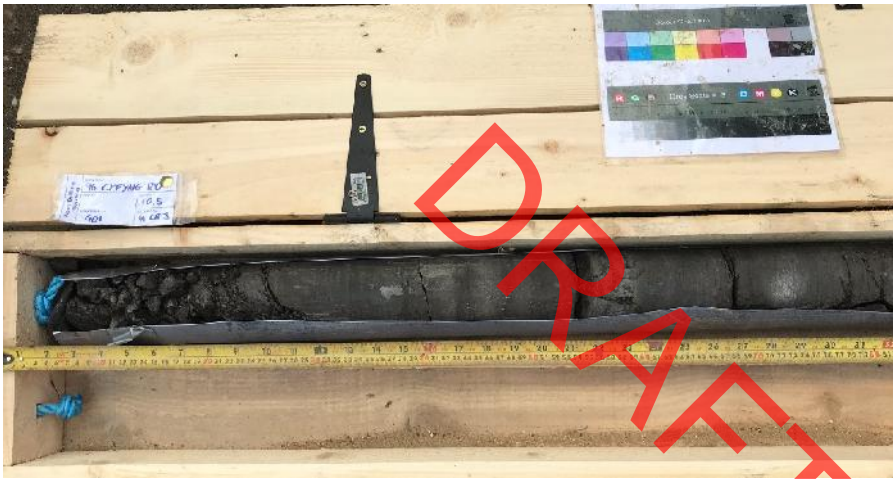
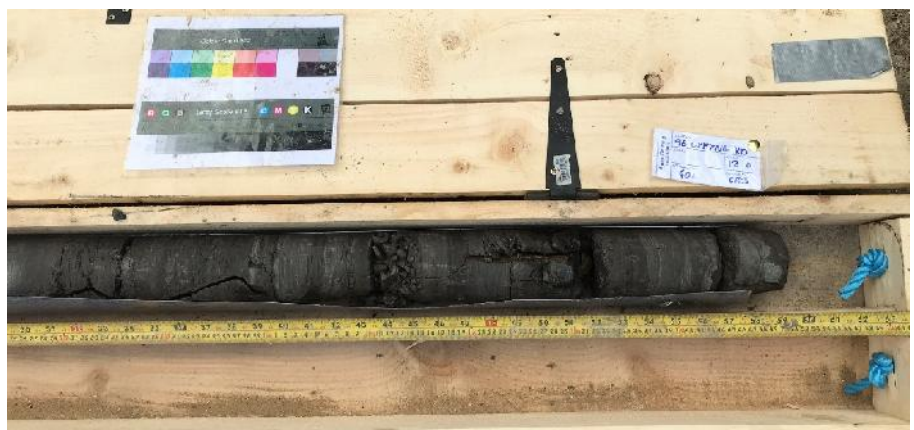
Borehole: **BH401**

Depth range: **10.5 – 12.0m**

Full core box overview

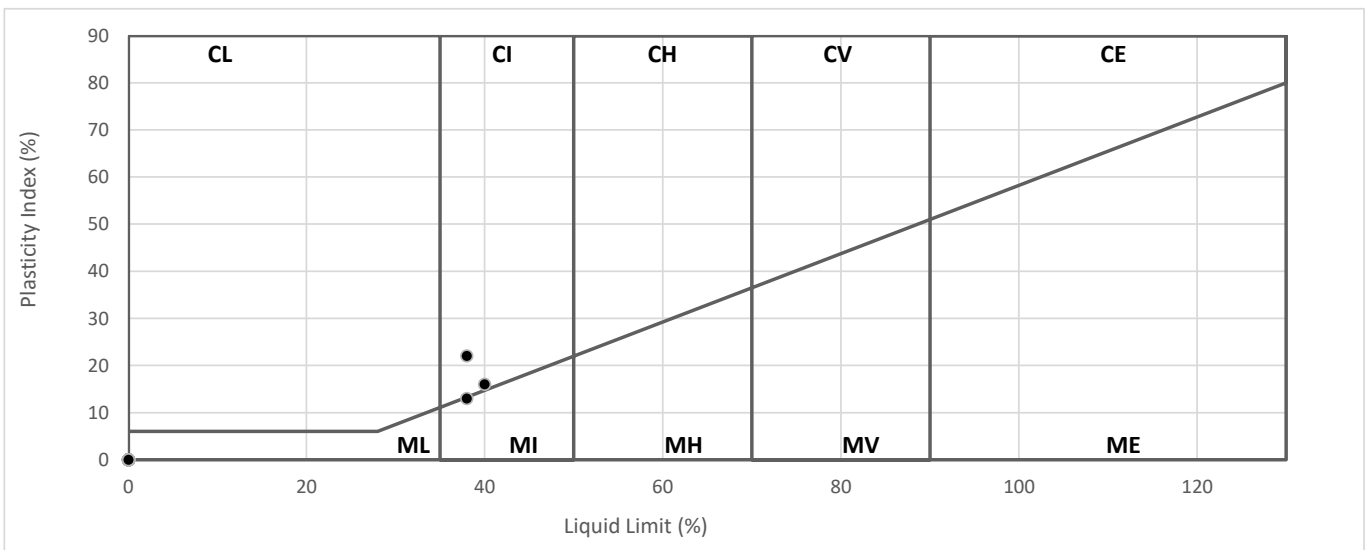
Hole Reference	Sample Number	Sample Type	Depth (m)		Moisture Content %	Liquid Limit %	Plastic Limit %	Plasticity index %	Passing .425mm %	Remarks
BH401	2		0.50	-	20	38	16	22	41	CI Intermediate Plasticity
BH401	1		3.80	-	27	40	24	16	62	CI Intermediate Plasticity
BH401	2		5.10	-	19	38	25	13	34	MI Intermediate Plasticity
				-						
				-						
				-						
				-						
				-						
				-						
				-						
				-						
				-						
				-						
				-						
				-						
				-						
				-						
				-						
				-						
				-						
				-						
				-						
				-						
				-

**PLASTICITY CHART FOR CASAGRANDE CLASSIFICATION
BS 5930:1999+A2:2010**

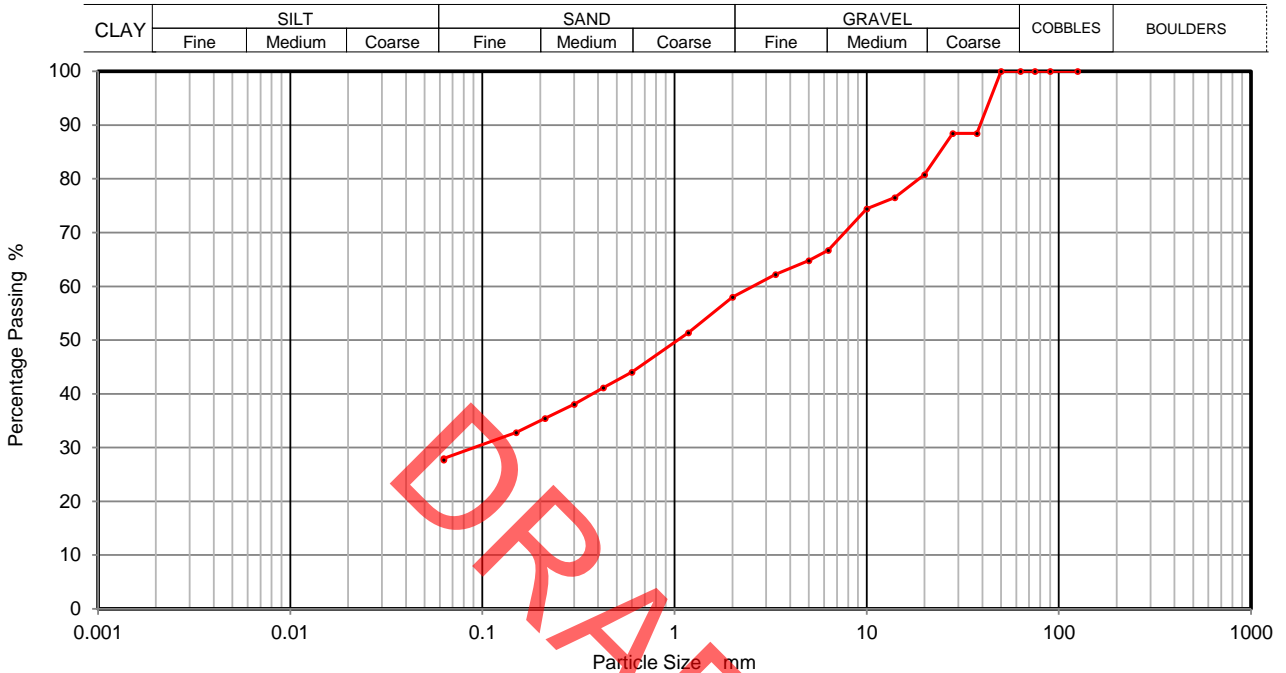
**PARTICLE SIZE DISTRIBUTION
BS 1377 Part 2:1990
Wet Sieve, Clause 9.2**

Soil Description **Brown silty clayey fine to coarse sandy fine to coarse GRAVEL.**

Depth Top **2.50**

Sample Proportions	% dry mass
Cobbles	0
Gravel	42
Sand	30
Silt and Clay	28

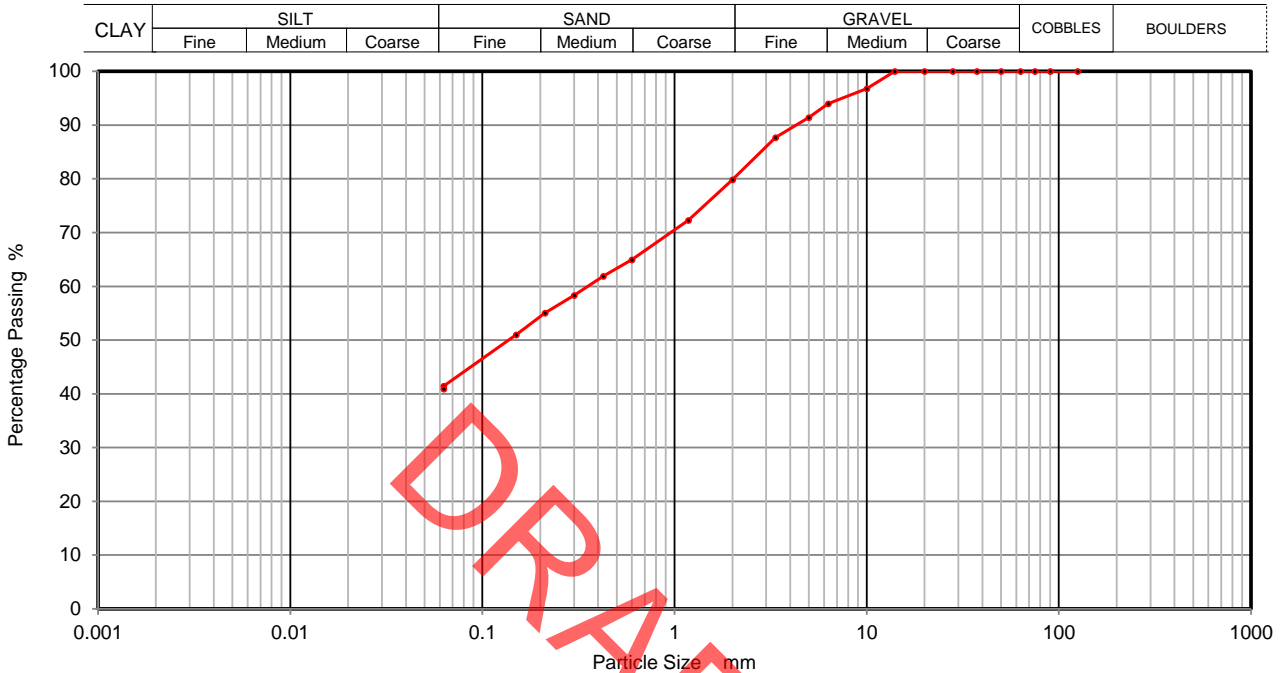
**PARTICLE SIZE DISTRIBUTION
BS 1377 Part 2:1990
Wet Sieve, Clause 9.2**

Soil Description
Grey fine to coarse gravelly fine to coarse sandy silty CLAY.

Depth Top **3.80**

Sample Proportions	% dry mass
Cobbles	0
Gravel	20
Sand	39
Silt and Clay	41

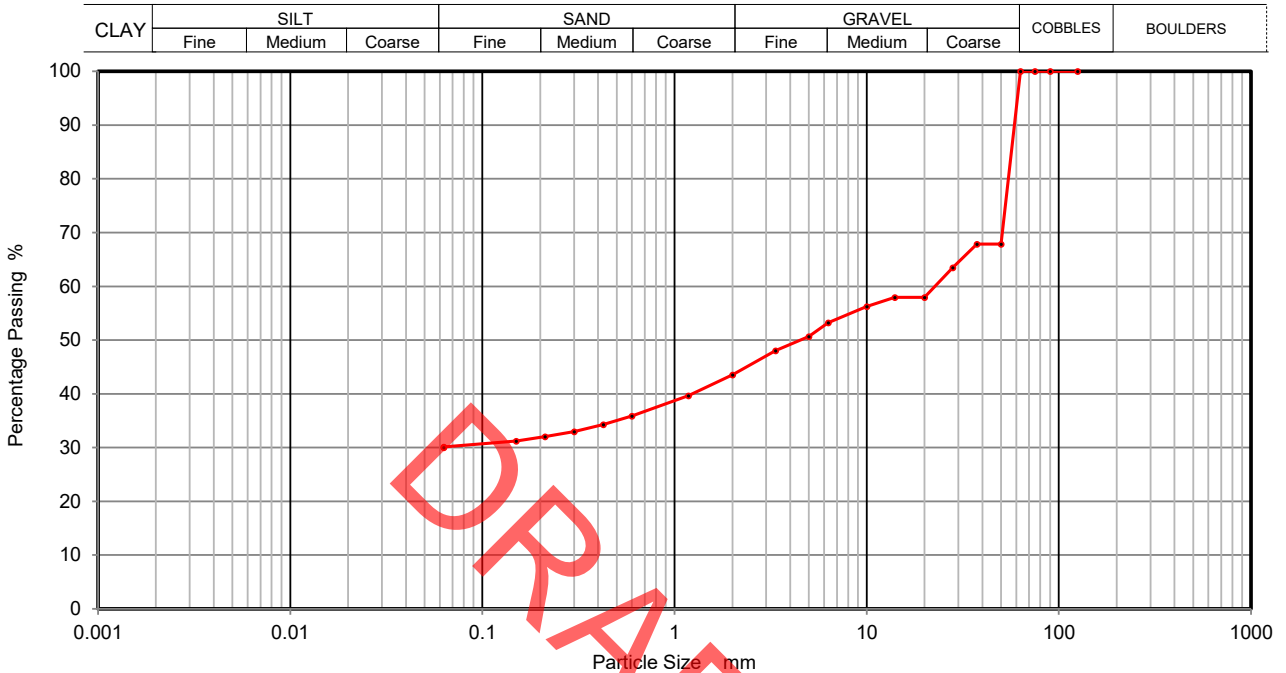
**PARTICLE SIZE DISTRIBUTION
BS 1377 Part 2:1990
Wet Sieve, Clause 9.2**

Soil Description **Brown fine to coarse sandy silty fine to coarse GRAVEL.**

Depth Top **5.10**

Sample Proportions	% dry mass
Cobbles	0
Gravel	56
Sand	14
Silt and Clay	30
